**DEPARTMENT OF DEFENCE  
DEFENCE SCIENCE AND TECHNOLOGY ORGANISATION  
AERONAUTICAL RESEARCH LABORATORIES**

Materials Technical Memorandum 374

DEVELOPMENT OF A TUBULAR COMPARATOR FOR RADIOPHASIC  
EVALUATION OF STEEL TUBE STRUCTURES

D.A. OLLEY

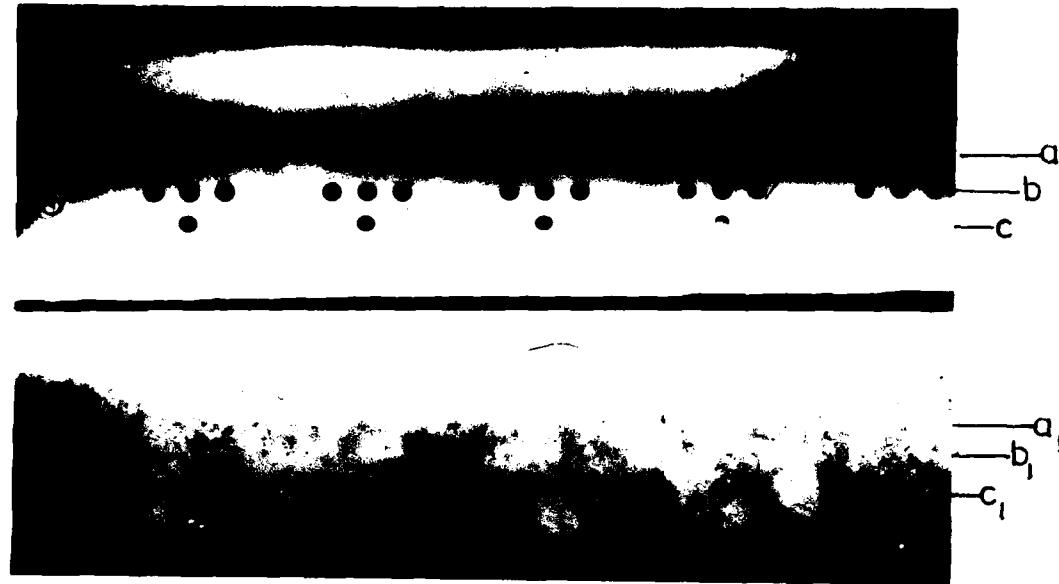
series of scan traces. Traces are taken along three reference paths (Fig. 3a,b,c) and, at least, three scan paths (Fig. 3a<sub>1</sub>,b<sub>1</sub>,c<sub>1</sub>) on the radiograph. The density traces, calibrated against density changes for known hole depths in the comparator tube, show directly the depth of corrosion pits, and/or reduction in wall thickness resulting from corrosion. When both general thinning of the tube wall and pitting occur, the trace exhibits 'peaks' above the base density level, corresponding to the pit sites. Thus, the pen trace indicates the profiles of pits which may act as stress raisers (Fig. 4).

FIG. 3. Shows radiographic images of comparator and corroded tube. Micro-densitometer reference scans are taken parallel to the tube axis at positions a, b and c for the comparator and a<sub>1</sub>, b<sub>1</sub>, and c<sub>1</sub> for the internally corroded tube.
